NASA
Technical
Paper
3222

Hot Fire Test Results of Subscale Tubular Combustion Chambers

John M. Kazaroff,
Robert S. Jankovsky,
and Albert J. Pavli

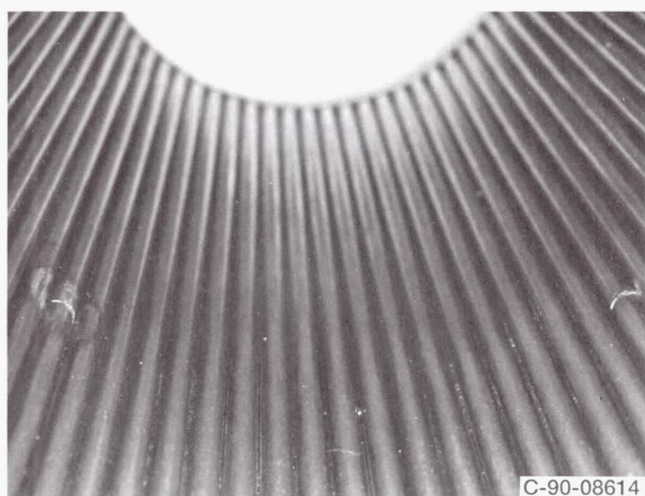
Figure 4.—Inside view of tubular chamber showing two installed crown thermocouples.

The drilling and grooving necessary to install these thermocouples significantly weakened the structure of this chamber. Because of this, the structural integrity of this chamber was seriously degraded, and it was used only to establish hot-gas-side wall temperatures as a function of liquid-hydrogen-coolant mass-flow rate. No life tests were performed on this chamber.

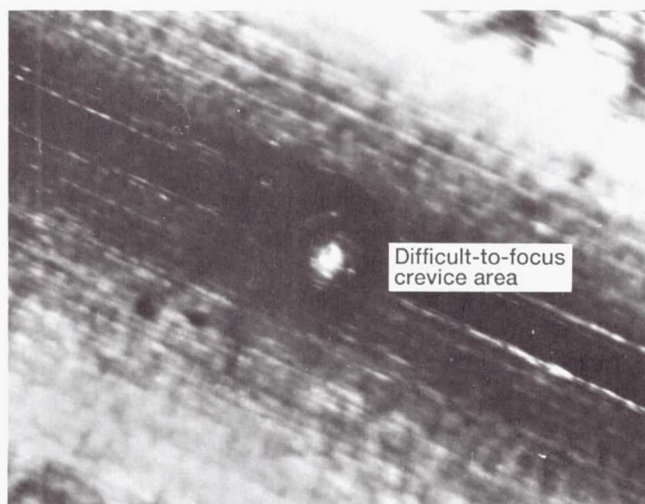
Figure 5.—Thermocouple junction in the crevice area.

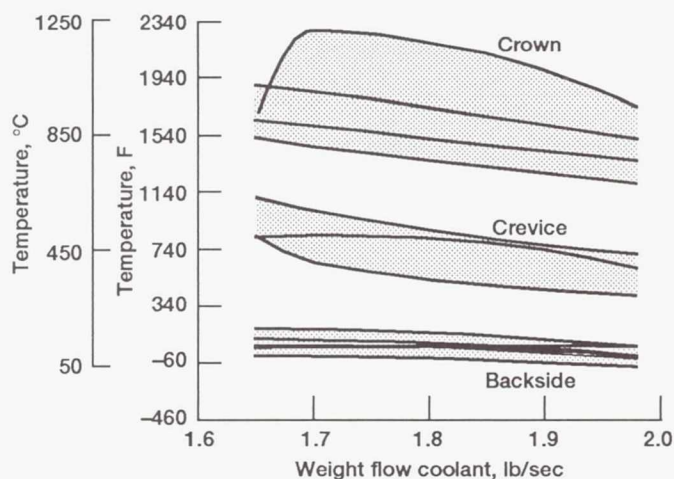
Figure 6.—Instrumented tube chamber data.

The first hot-fire tests were performed to determine flow set points and to measure the hot-gas-side wall temperatures. The results of these tests are shown in figure 6, which is a plot of the various temperature measurements as a function of coolant flow rate. The melting-point temperature of the OFHC copper tubes is 1083 °C (1981 °F). Clearly, some of the crown thermocouples were not correct. The measurement of crown temperatures by milling away almost one-half of the wall thickness, to provide a groove for the thermocouple and then replacing the copper of that groove with stainless steel, ceramic, and chromel/alumel wires, may have unduly affected the true crown temperatures. The crevice temperature thermocouples, however, are located in a more forgiving environment and are more likely to provide some insight into the severity of the thermal environment.

the crevice for the configuration tested and analyzed. This value has been shown by posttest analysis to be somewhat less than 222 °C (400 °F). By applying this increment to the measured crevice temperatures at the maximum coolant flow condition of 0.841 kg/sec (1.98 lb/sec), we can predict a range of crown temperatures with a maximum of 570 °C (1060 °F). This was the condition that was selected for the fatigue test of the second chamber. The second chamber was test fired for 637 cycles with no sign of fatigue cracks. Since this chamber exceeded the life of an equivalent milled-channel configuration by over a factor of three, testing was stopped. Reference 5 predicts a life of 200 cycles for the 72 milled-channel configuration if tested at a wall temperature of 570 °C (1060 °F).

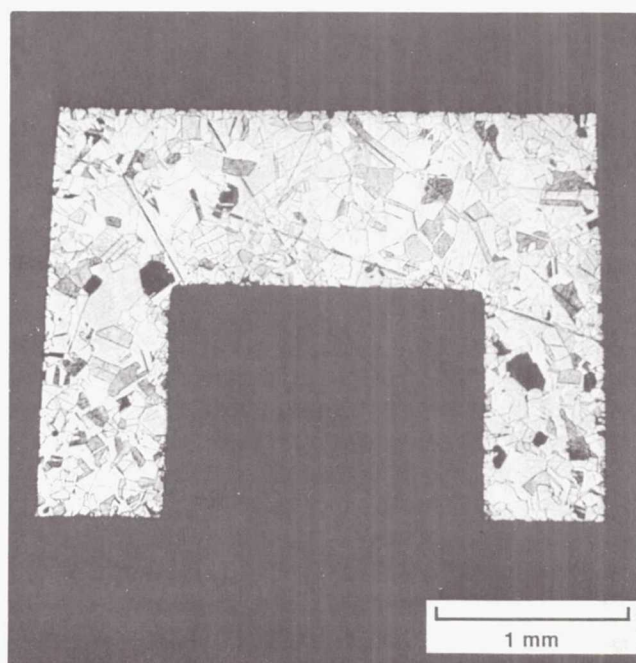
Figure 18.—Grain size specimen from annealing study, 10 min at 770 °C (1400 °F).

Grain growth phenomena of OFHC copper was also examined in reference 8. In this work coupons of OFHC copper were subjected to a variety of temperatures. The coupons were ground, polished, etched, and then photographed to compare them with the tubular thrust chamber specimens. This was done to obtain better definition of the thermal environment to which the specimens had been exposed. Figure 18 was taken from the work reported in reference 8. This figure shows the grain size obtained after heating an OFHC copper channel 10 min at 760 °C (1400 °F). The photograph was taken at a magnification of 25×. For comparison, a sample of

the wall material of a fired chamber (also photographed at 25×) is shown in figure 19. The grain sizes are equivalent, indicating that they had been exposed to the same temperature. However, the tube sample of figure 19 was taken from a location of 0.42 cm (0.16 in.) downstream of the throat area.

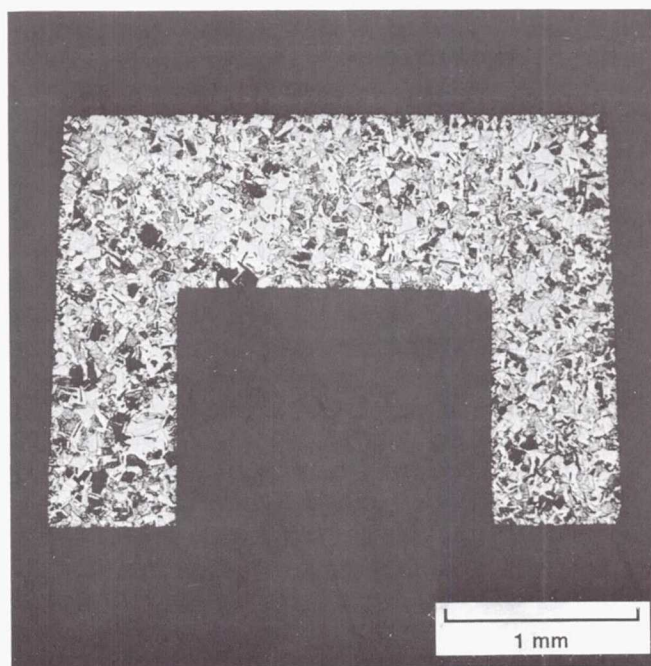
Figure 20.—Grain size specimen from annealing study, 10 min at 538 °C (1000 °F).

Figure 20 shows the grain size resulting from exposure to 538.1 °C (1000 °F). Grains of this size are also seen in figure 19, which shows an area just below the crevice region. This indicates that the temperature in the crevice region was slightly higher than 538.1 °C (1000 °F). This accounts for a crown to crevice difference of just under 204.4 °C (400 °F), which agrees reasonably well with the analytical prediction of 171.4 °C (340 °F) for this difference.
